TS POWER PLANT CCR LANDFILL – 2021 INSPECTION

Nevada Gold Energy, LLC
914 Dunphy Ranch Road
Battle Mountain, Nevada 89820

NewFields Project 475.0221.009
October 18, 2021

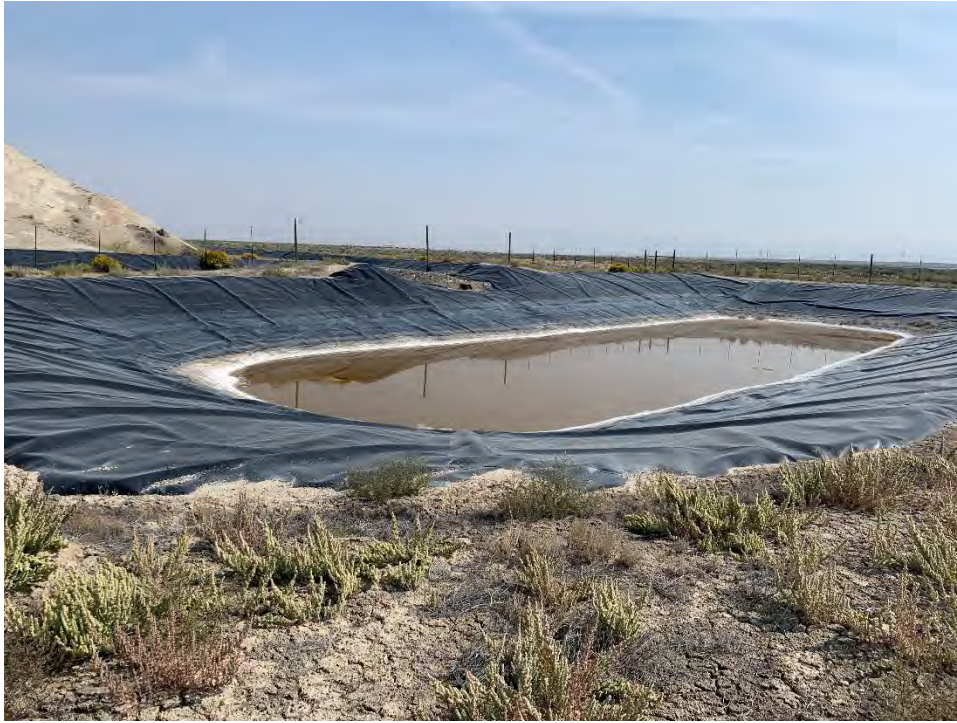
As shown in Photographs 1, 2 and 3, the collection pond had a water level approximately 8 feet below the inlet spillway, with minimal water in the collection pond. Minor sediment and vegetation were observed along the east embankment of the collection pond. No leachate flow from the landfill to the pond was observed at the time of the inspection. The HDPE geomembrane was in good condition and no damage or defects were noted. The perimeter fencing and signage is maintained and in good condition.

2.7 Miscellaneous		X		
3.0 General				
3.1 Solution Pond(s)	X		1, 2 and 3	External Stormwater/Leachate Collection Pond. Composite lined with 80-mil HDPE over GCL.

Photo 1. Collection Pond 1 - View Northeast

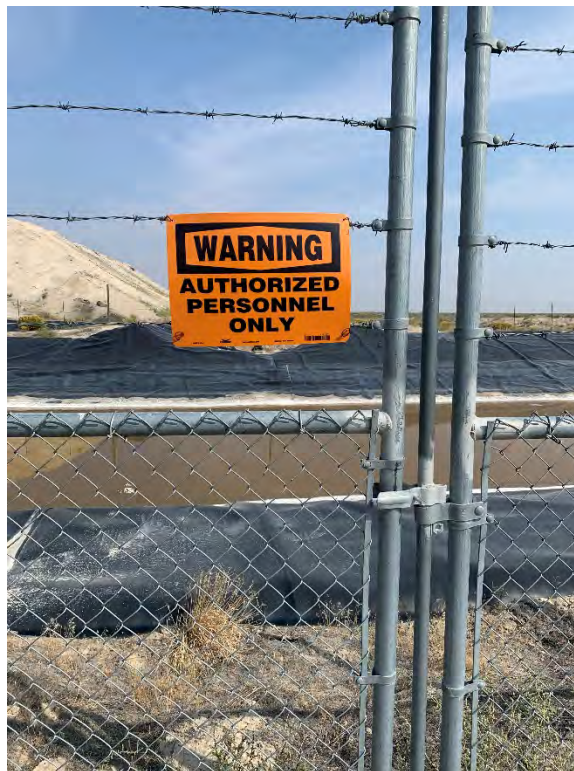
Photo 2. Collection Pond 1 Gate

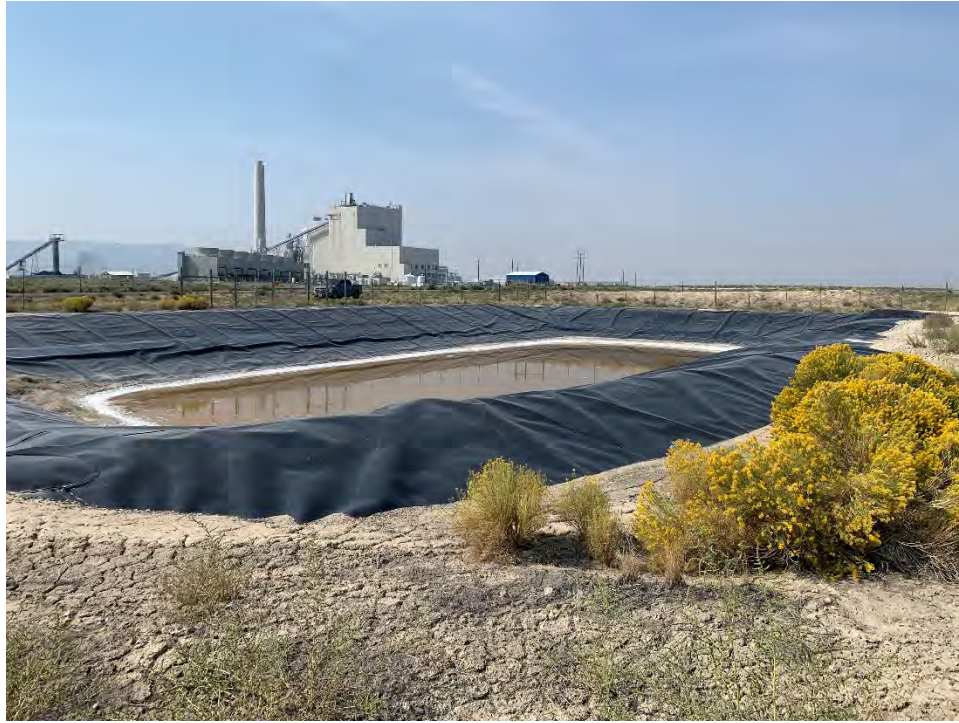
Photo 3. Collection Pond 1 - View Southwest

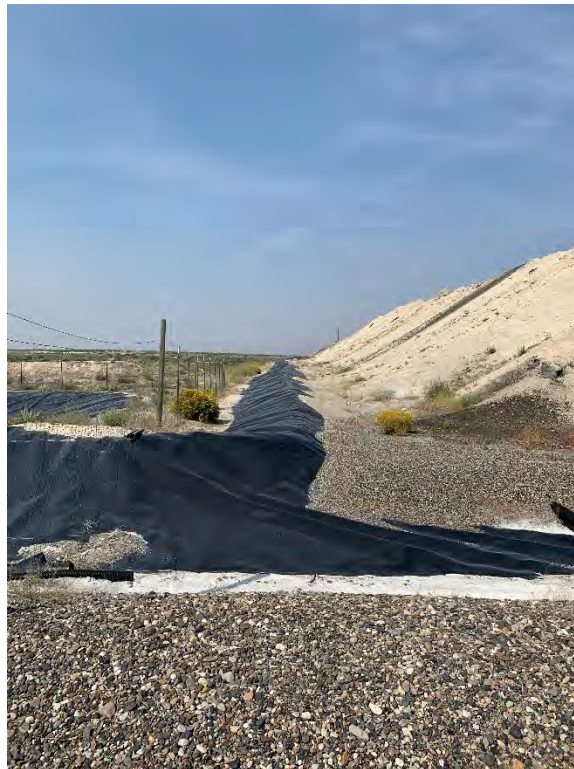
OBSERVED FEATURES	YES	NO	PHOTO NOS.	COMMENTS / NOTES
1.0 Facility Perimeter				
1.1 Evidence of Erosion		X	4,6,7,14, and 16	No erosion along the perimeter of the landfill berms was noted.

1.6 Other Unusual Conditions		X		
1.7 Evidence of Repairs		X		
2.0 Landfill Materials				
2.1 Lateral Movement	X	X	4,6 and 16	Some minor sloughing noted in 2017-2020 inspections; No change in 2021 inspections.

Photo 4. South Perimeter Berm, Southeast Corner, Cell 1 - View West

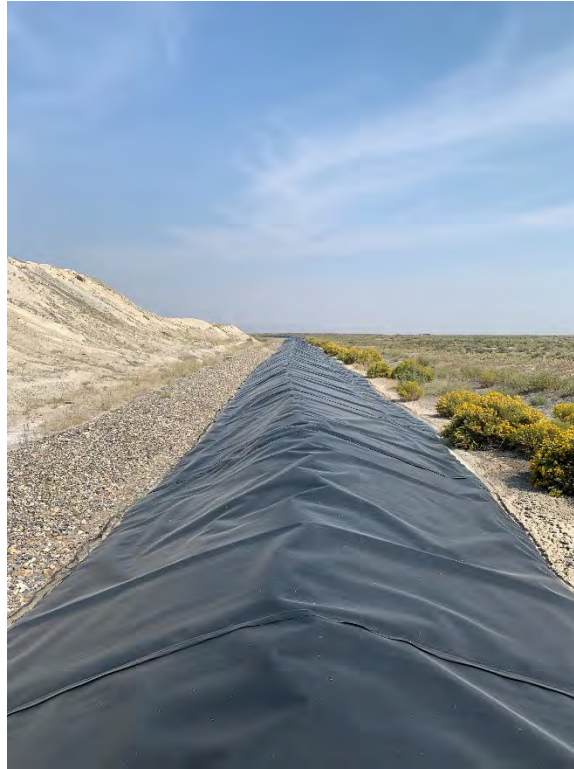
Stormwater is routed around the perimeter of the facility by diversion channels and/or the perimeter berms that surround the landfill. Typical diversions are shown in Photographs 4, 5, 8, 9, 11, 12, 15, and 16. An access ramp over the perimeter berm is located near the southwest corner of Cell 1 (Photograph 15). A secondary access into Cell 2 has been planned and partially constructed. A geomembrane wear sheet has been installed over the perimeter berm liner at the location of the planned secondary access. The secondary access includes a culvert to facilitate stormwater management. This culvert is yet to be installed. Stormwater controls were observed to be consistent with the intent of the design and no significant issues were noted as part of the inspection.

Photo 5. East Perimeter Berm, Southeast Corner, Cell 1 - View North

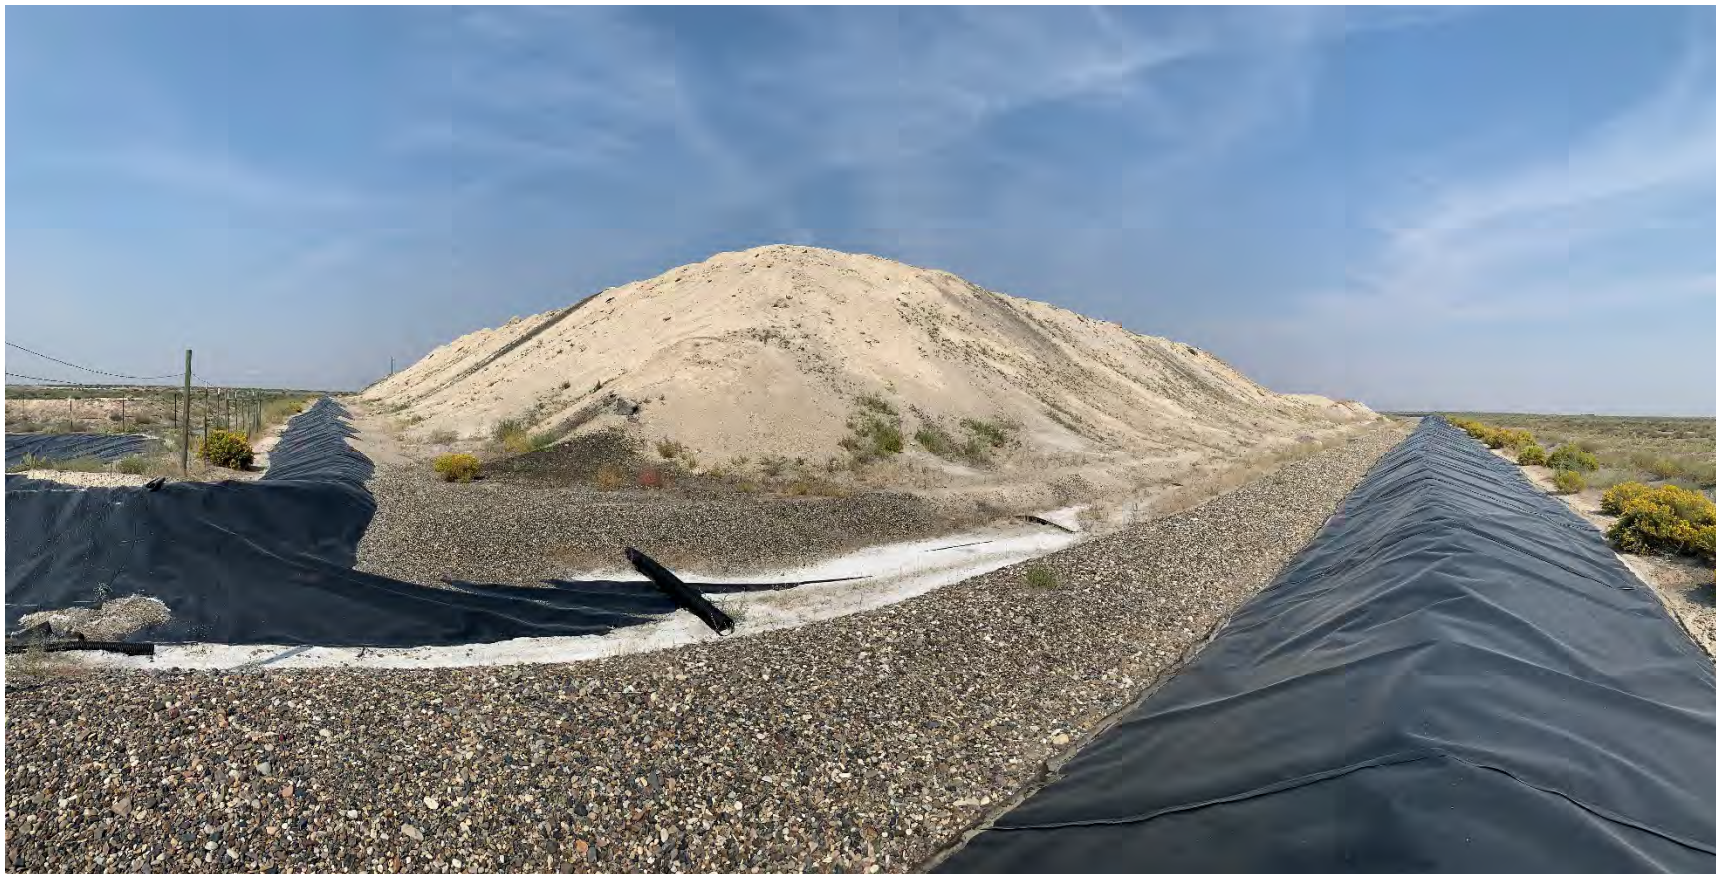
Photo 6. Panoramic Southeast Corner of CCR, Cell 1 - View Northwest

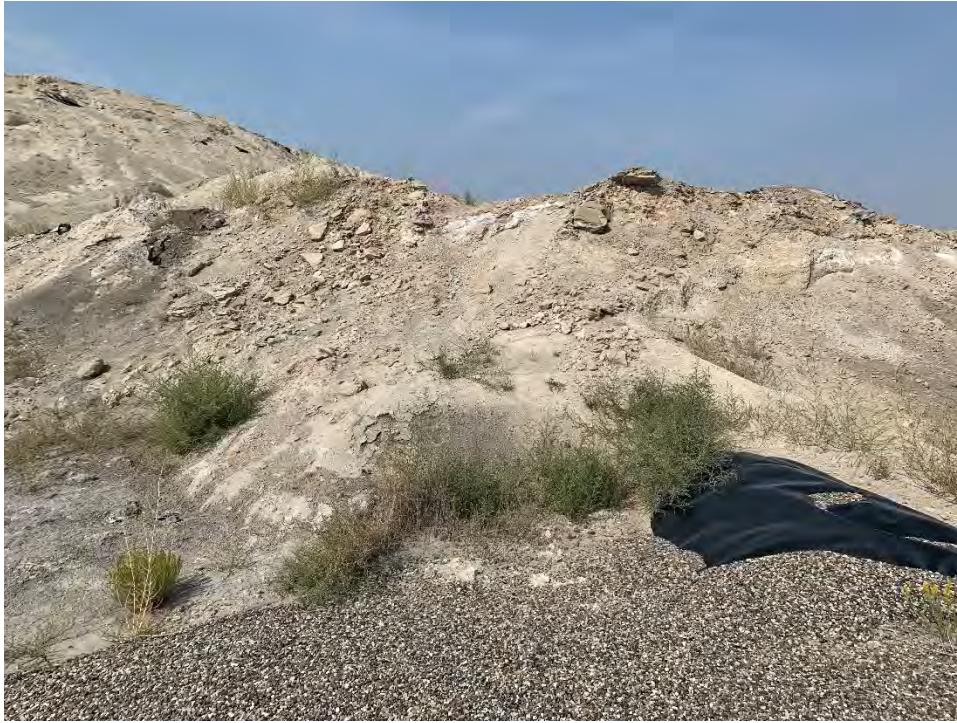
Photo 7. Left to Right Cell 1 - Cell 2 Transition. View West

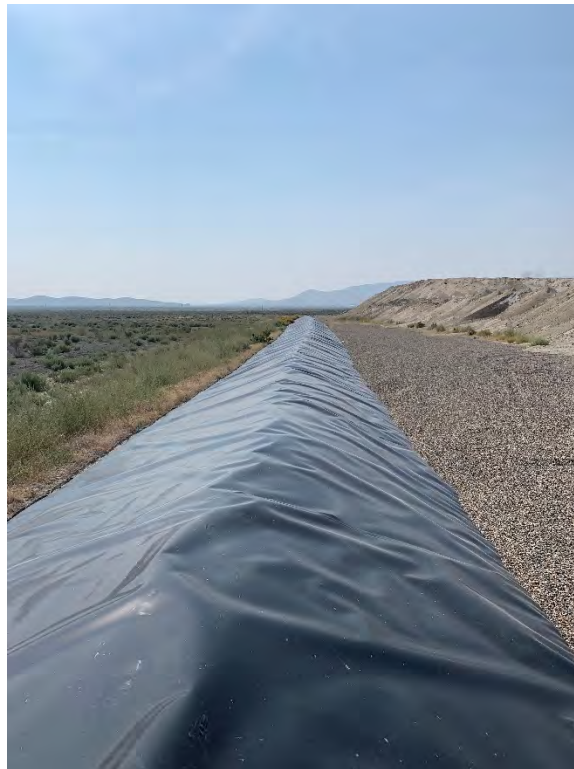
Photo 8. East Perimeter Berm, Northeast Corner, Cell 1 and 2 - View South

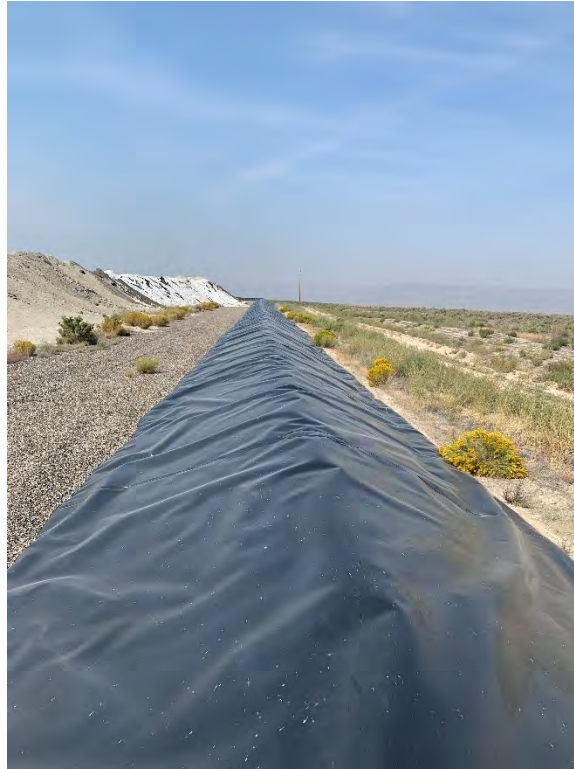
Photo 9. North Perimeter Berm, Northeast Corner, Cell 2 - View West

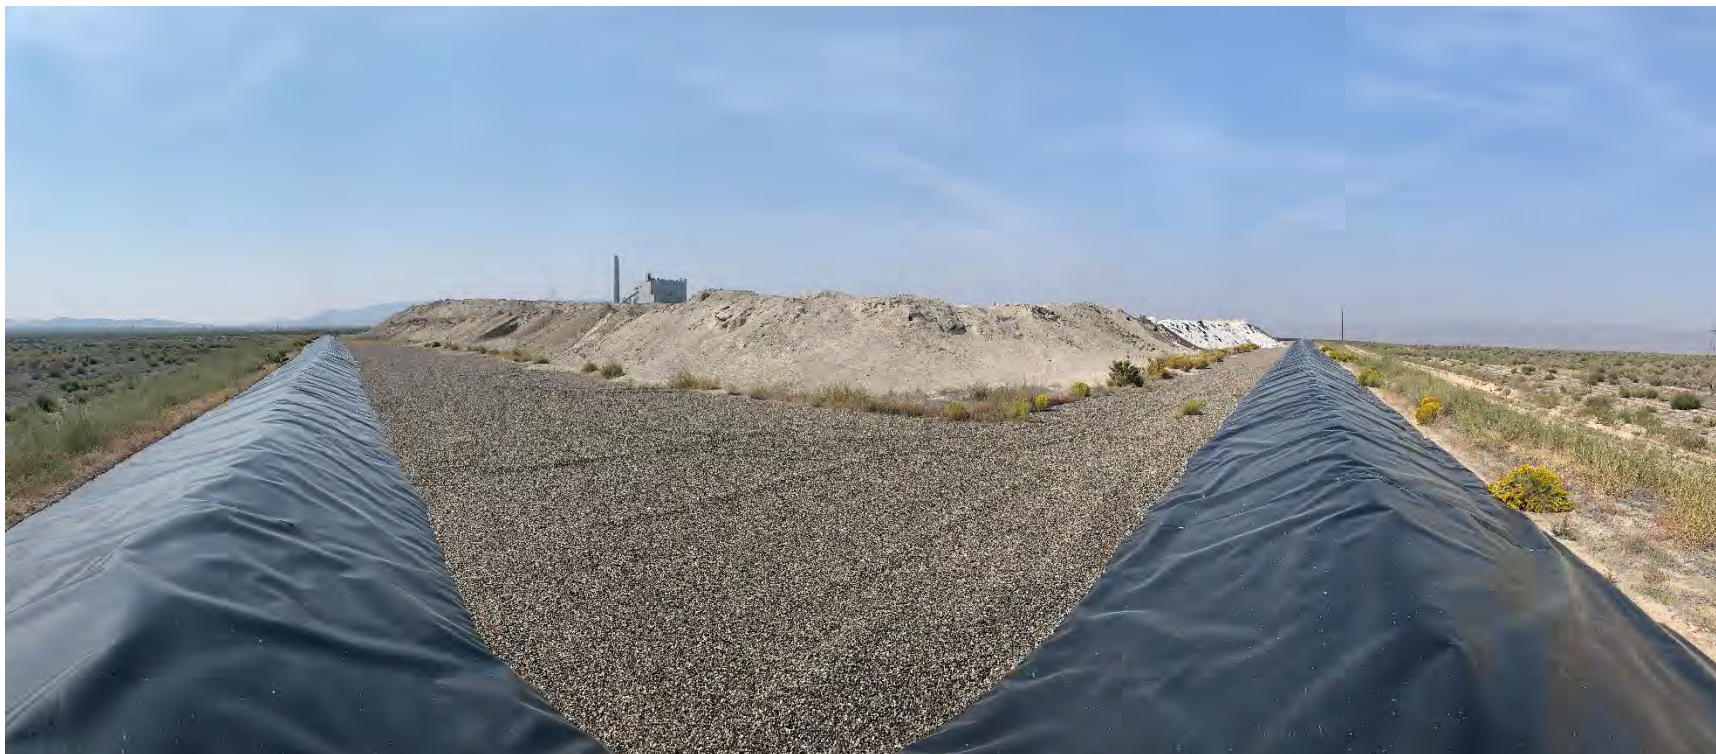
Photo 10. Panoramic Northeast Corner of CCR, Cell 2 - View Southwest

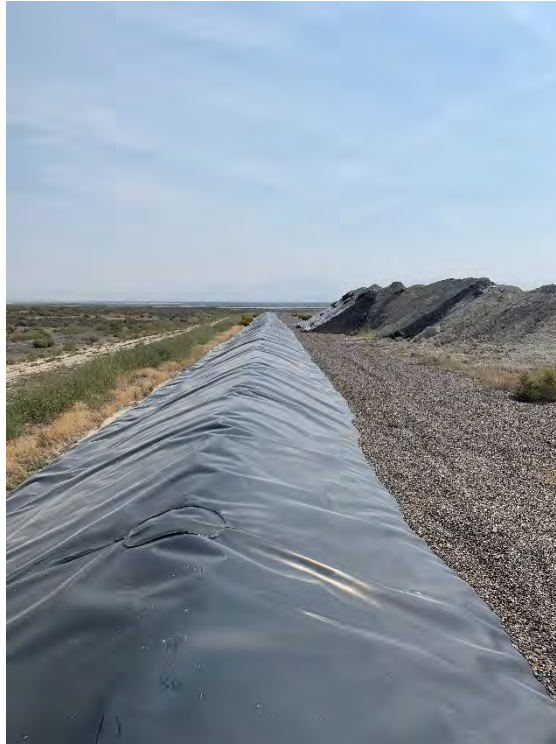
Photo 11. North Perimeter Berm, Northwest Corner, Cell 2 - View East

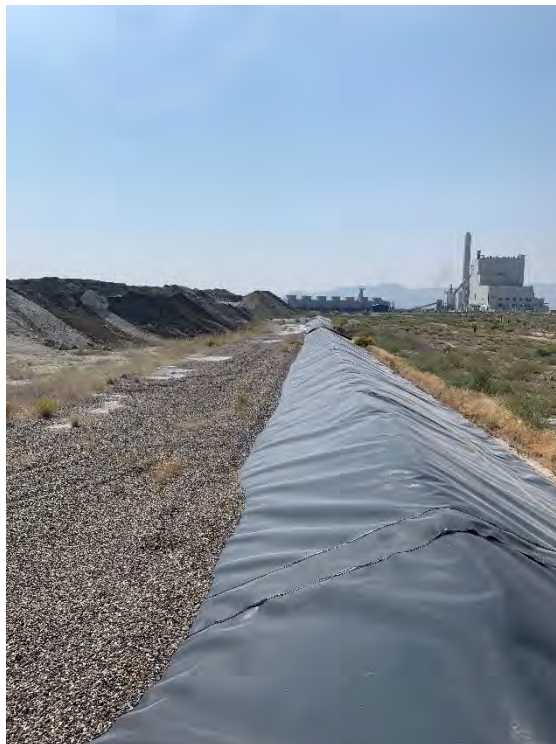
Photo 12. West Perimeter Berm, Northwest Corner Cell 2 - View South

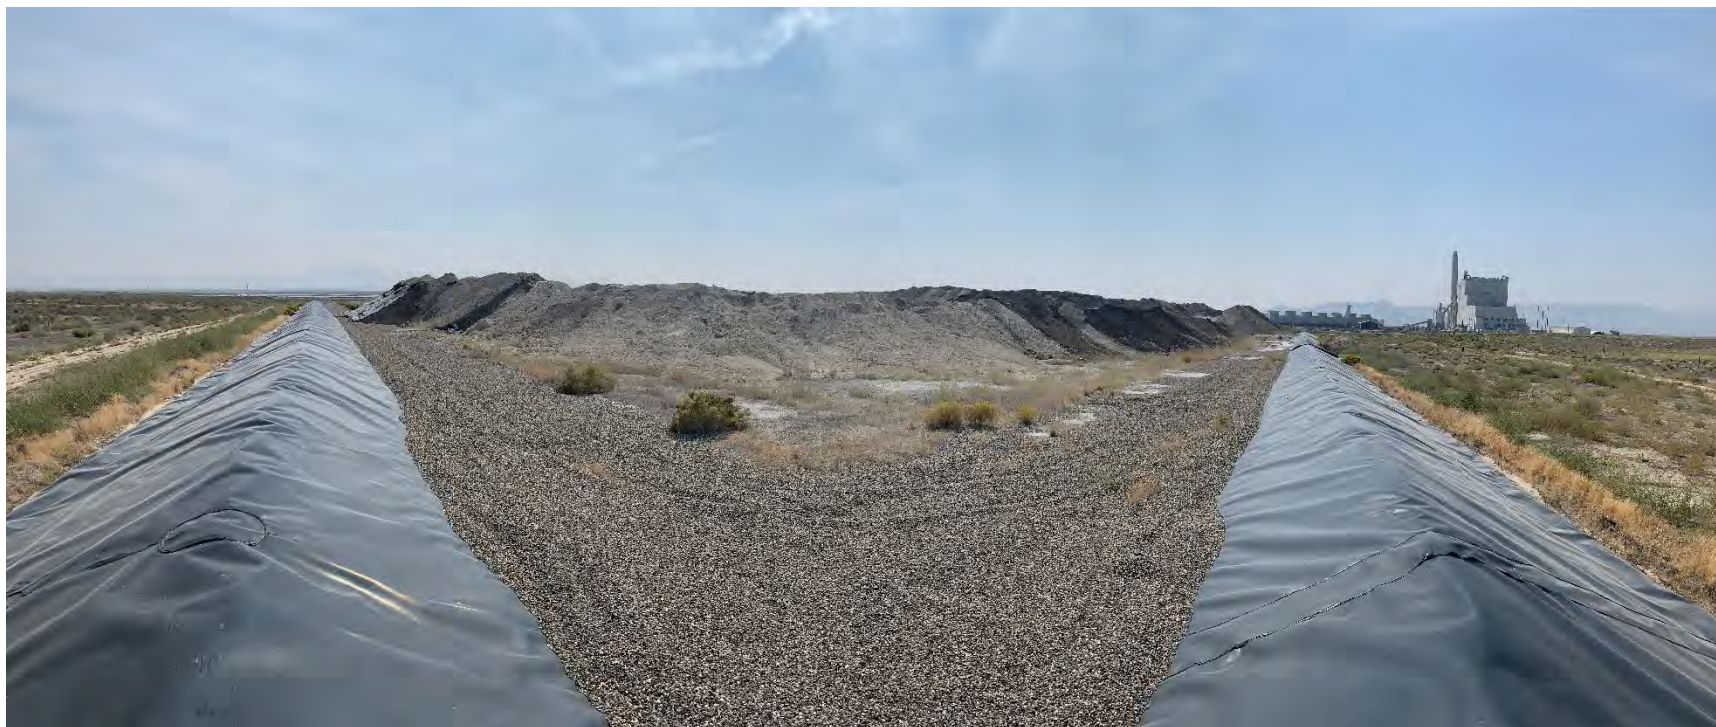
Photo 13. Panoramic Northwest Corner of CCR, Cell 2 - View Southeast

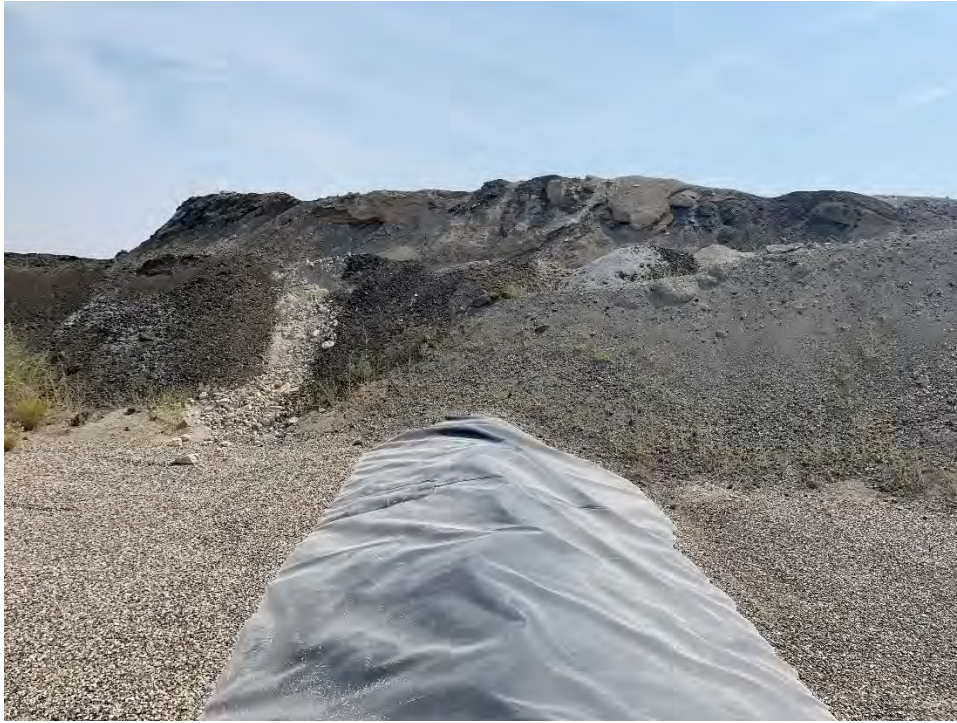
Photo 14. Left to Right Cell 2 – Cell 1 Transition - View East

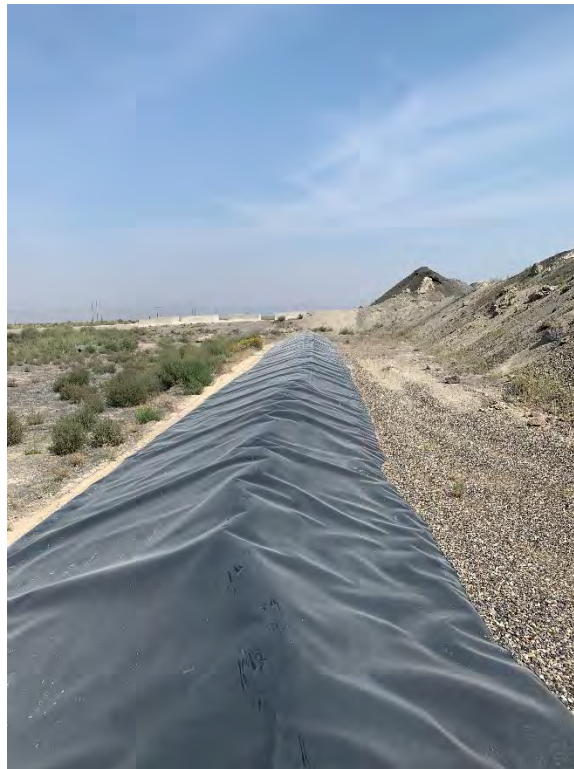
3.2 Embedded/buried structures		X		
3.3 Accessible by Truck	X		15	Landfill access ramp. Secondary Access wear sheet needs additional securing. Secondary Access needs stormwater pipe installed

Photo 15. West Perimeter Berm and Access Point, Southwest Corner, Cell 1 - View North

- To expand facilitate access and improve utilization, the secondary access into Cell 2 should be completed. This requires the installation of a stormwater culvert under the access and securing of the wear sheet over the existing liner. Until the access is complete, the wear sheet should be properly secured by fusing welding to the primary liner to prevent any liner damage.
- Continuing documentation of the monitoring activities, including visual inspections of the facility (ongoing by TSPP personnel).
- Periodically check drainage channels and culverts for blockage and sediment to confirm functionality (ongoing by TSPP personnel).

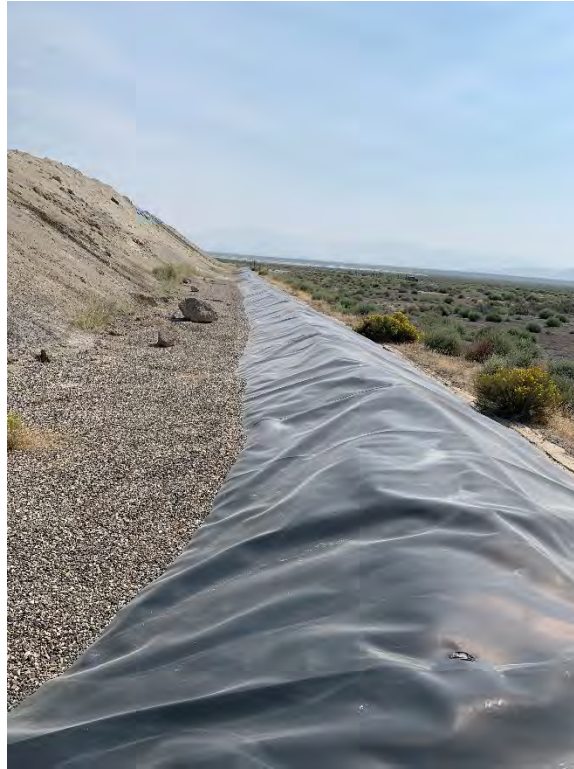
Photo 16. South Perimeter Berm, Southeast Corner, Cell 1 - View East

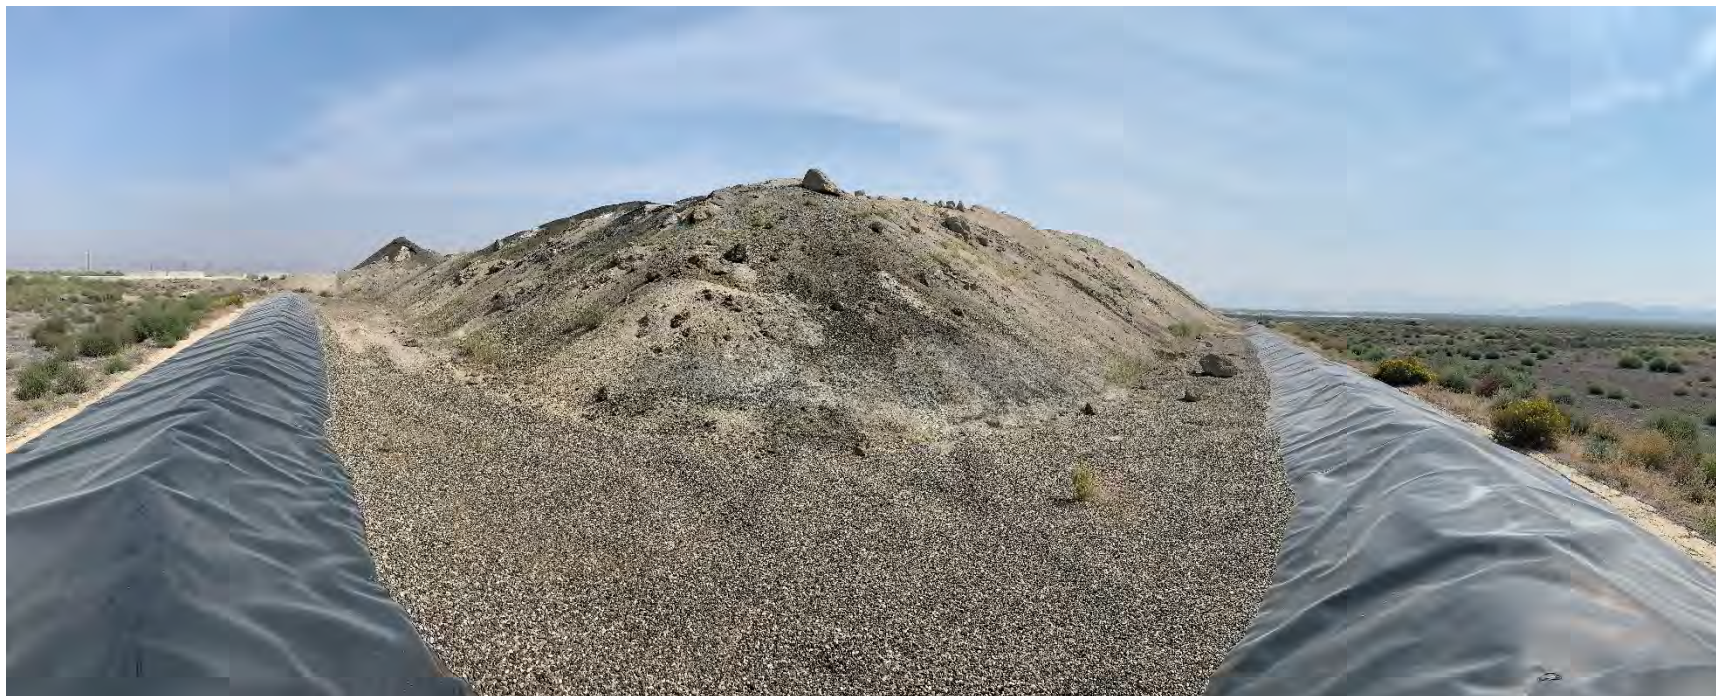
Photo 17. Panoramic Southwest Corner of CCR Cell 1 - View Northeast

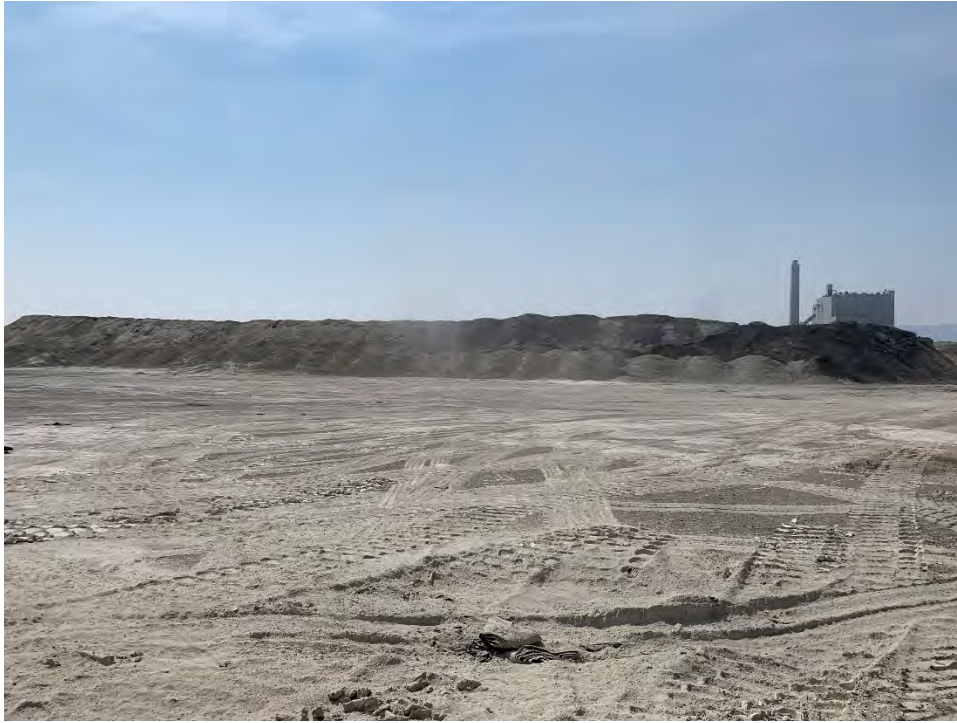
Photo 18. Cell 2 First Lift Deposition - View South to Cell 1

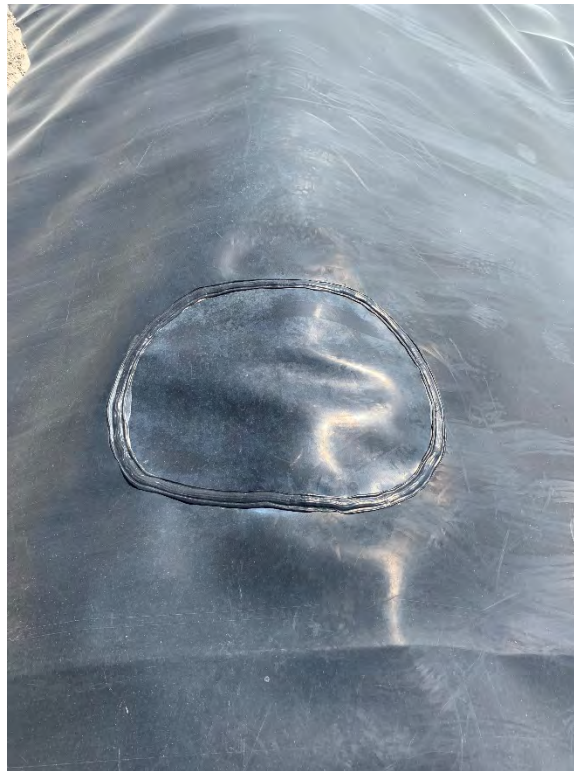
3.4 Public Access - Pond		X	See 3.1	Area signed and fenced.
3.5 Liner Conditions	X		19 and 20	Repairs completed during summer 2021.
3.6 Other Unusual Conditions		X

Photo 19. Liner Repair – Cell 1 South Berm Crest

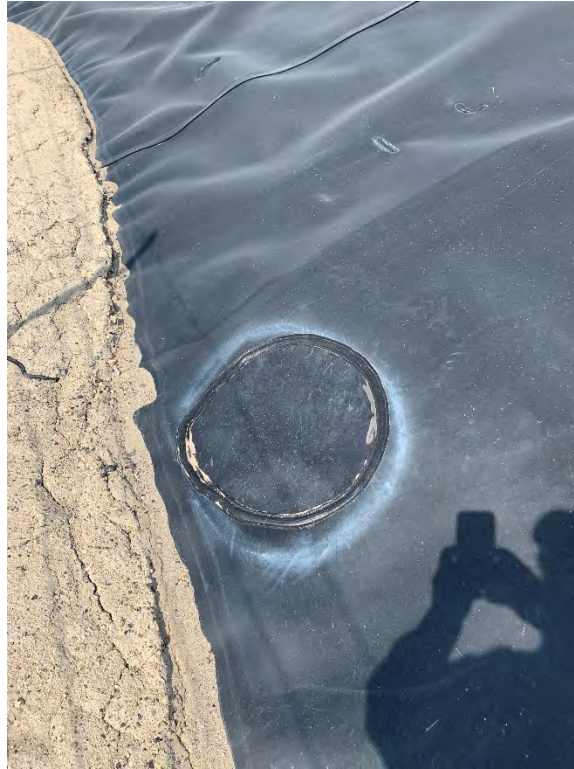
Photo 20. Liner Repair – Cell 1 South Bern Downstream Toe
